HYDROGRAPHIC SURVEY

U.S. ARMY ENGINEER DISTRICT
CORPS OF ENGINEERS
WILMINGTON, NORTH CAROLINA

Big Foot Slough

OCRAOKE, NORTH CAROLINA

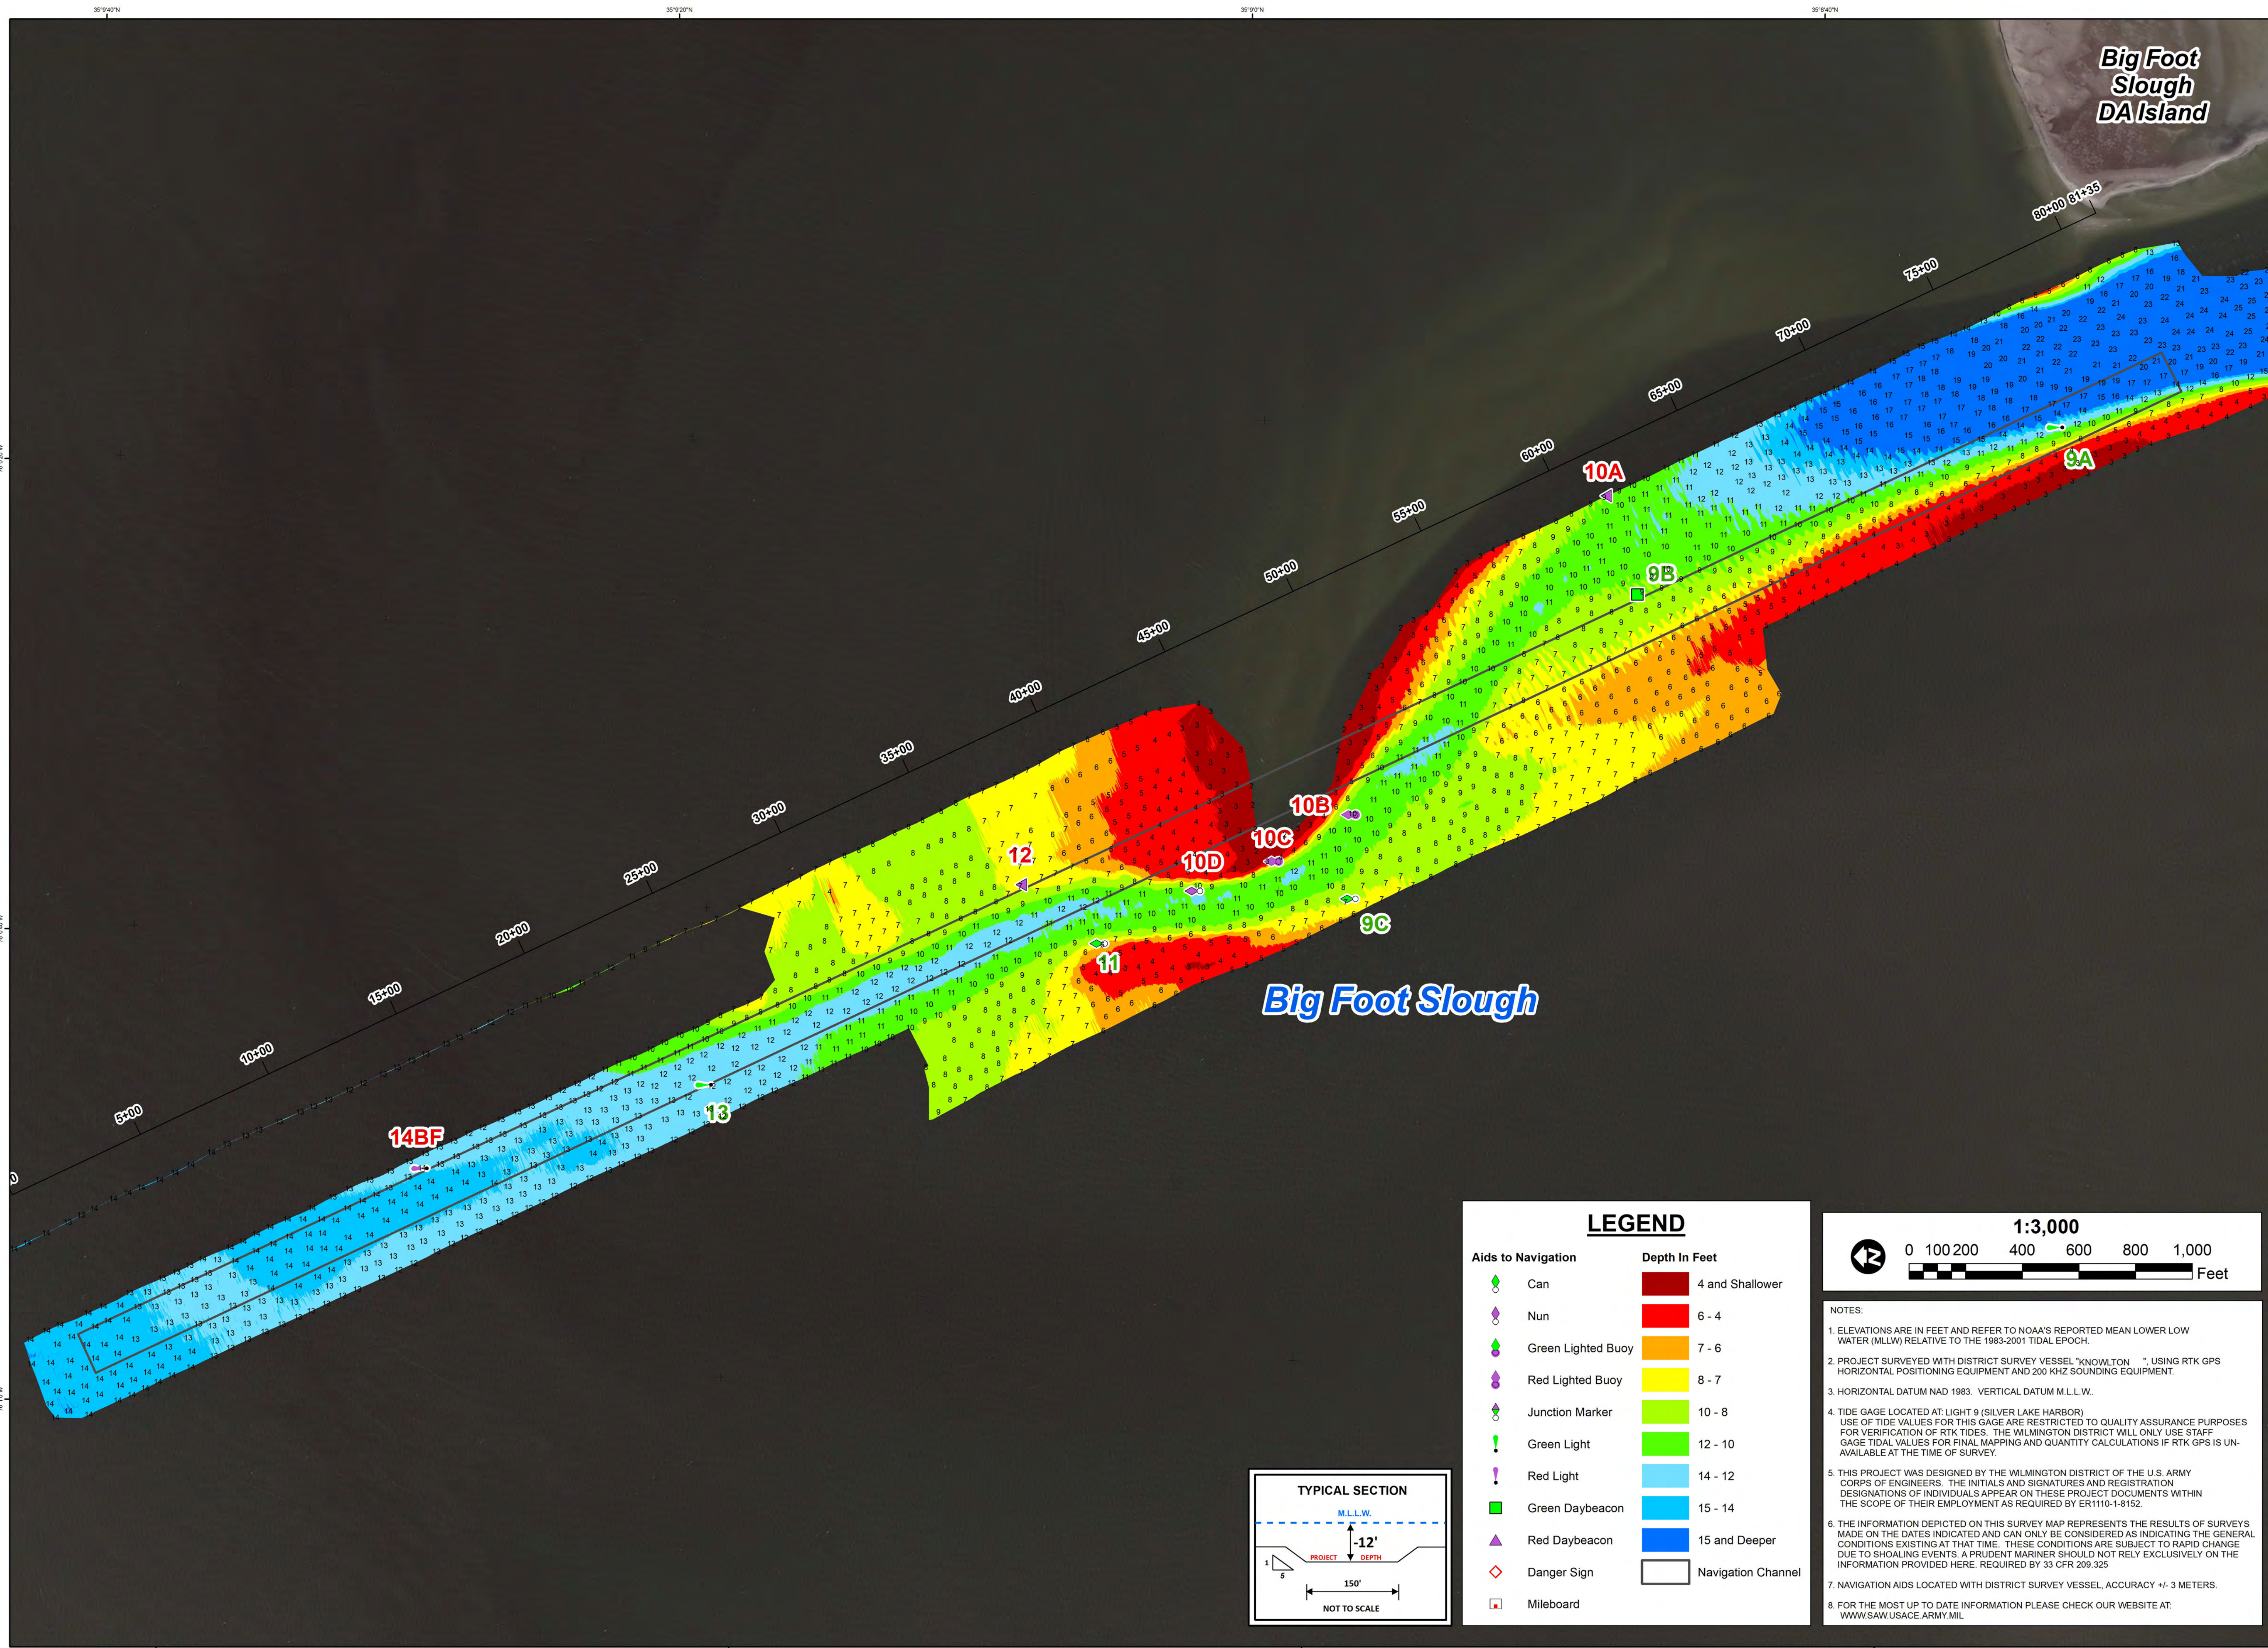
SURVEY DATE: 21 APRIL 2021	SURVEYED BY: DCH, SSS
MAP DATE: 12 MAY 2021	MAPPED BY: K7OPNLAC
MAP SCALE: 1:3,000	PROCESSED BY: K7OPNLAC
IMAGERY DATE: 16 FEBRUARY 2021	MAP FILE NAME: SL_04_BIG_20210421_CS

- ELEVATIONS ARE IN FEET AND REFER TO NOAA'S REPORTED MEAN LOWER LOW WATER (MLLW) RELATIVE TO THE 1983-2001 TIDAL EPOCH.
- PROJECT SURVEYED WITH DISTRICT SURVEY VESSEL "KNOWLTON" USING RTK GPS HORIZONTAL POSITIONING EQUIPMENT AND 200 KHZ SOUNDING EQUIPMENT.

- HORIZONTAL DATUM NAD 1983. VERTICAL DATUM M.L.L.W.
- TIDE GAGE LOCATED AT: LIGHT 9 (SILVER LAKE HARBOR) USE OF TIDE VALUES FOR THIS GAGE ARE RESTRICTED TO QUALITY ASSURANCE PURPOSES FOR VERIFICATION OF RTK TIDES. THE WILMINGTON DISTRICT WILL ONLY USE STAFF GAGE TIDAL VALUES FOR FINAL MAPPING AND QUANTITY CALCULATIONS IF RTK GPS IS UNAVAILABLE AT THE TIME OF SURVEY.

- THE INFORMATION DEPICTED ON THIS SURVEY MAP REPRESENTS THE RESULTS OF SURVEYS MADE ON THE DATES INDICATED AND CAN ONLY BE CONSIDERED AS INDICATING THE GENERAL CONDITIONS EXISTING AT THAT TIME. THESE CONDITIONS ARE SUBJECT TO RAPID CHANGE DUE TO SHOALING EVENTS. A PRUDENT MARINER SHOULD NOT RELY EXCLUSIVELY ON THE INFORMATION PROVIDED HERE. REQUIRED BY 33 CFR 209.325
